# Sequential Data Analysis for Black Spot Identification

Presented at  
4<sup>th</sup> IRTAD Conference Seoul  
by

Department of Highways  
Ministry of Transportation  
The Kingdom of Thailand

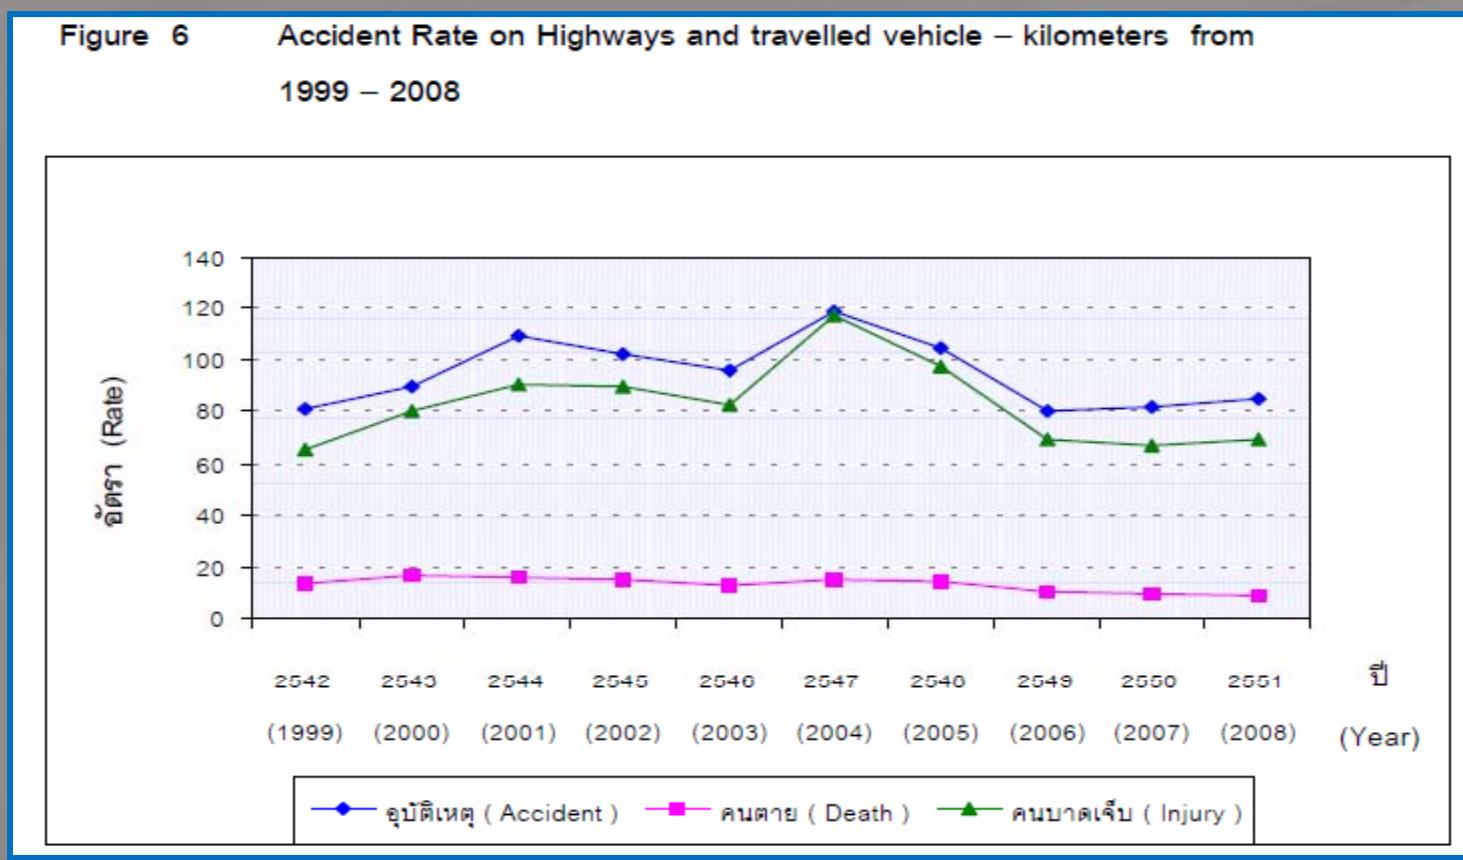
- Hazardous location improvement > 470 locations
- Rail-crossroad improvement > 226 locations
- 10-year trend of accident rates on highways

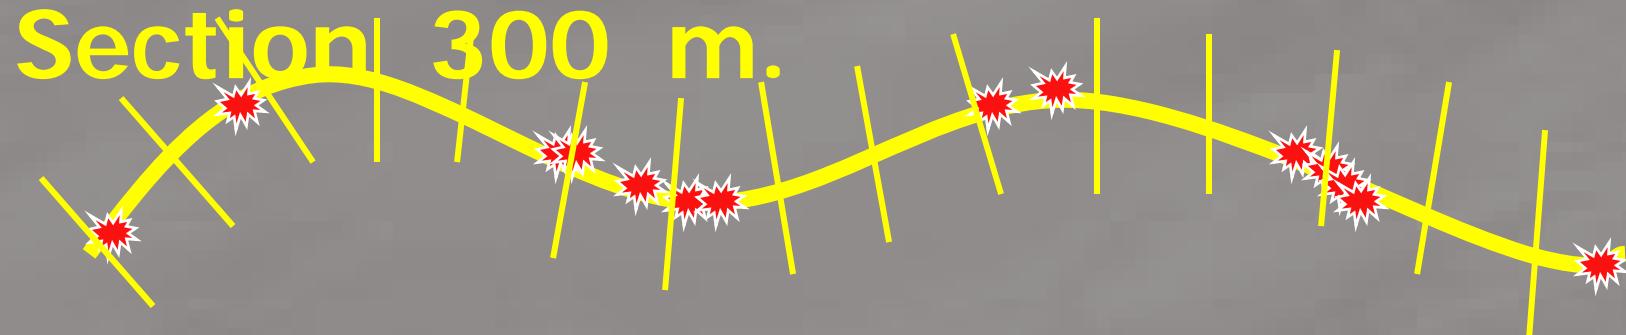
Conventional Method -

- fixed length of road section could overlook the spots that are closed to each other but located in different sections
- In the same section, accidents may or may not be identified as they are correlated

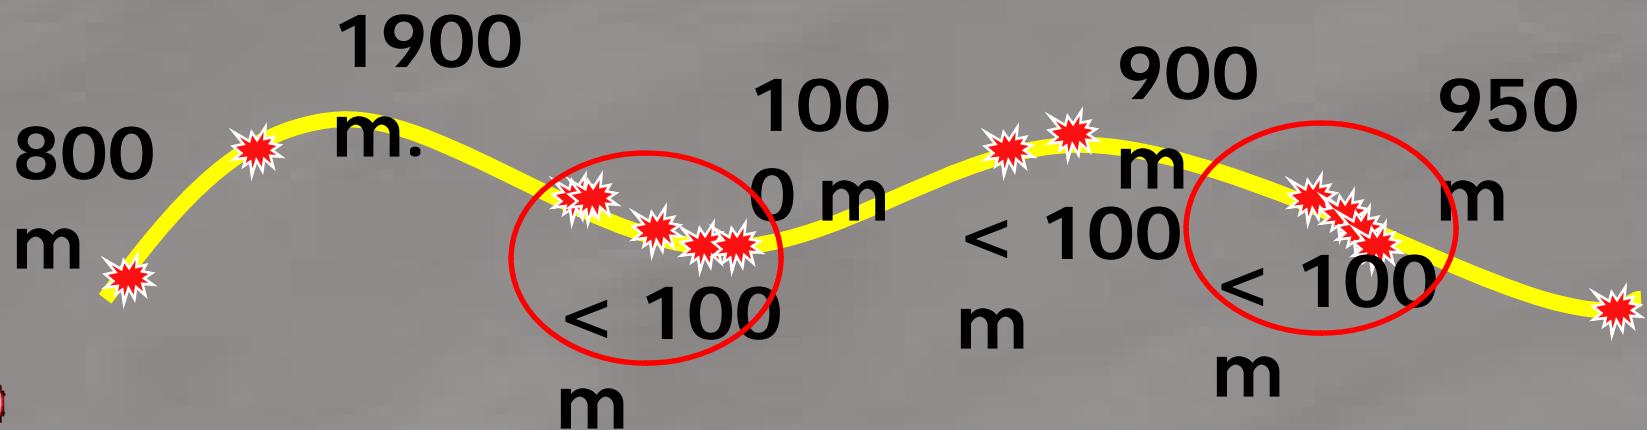
Sequential Pacing Data Analysis Me

- Mimic the way that road inspectors travel along a highway and inspect all accident records
- **Criteria:** nearby accidents within 100-meter of distance will be grouped together as a black spot location (**3 times** of accident occurrences), where any accident located farther than 100-meter away from the current location will be assigned another black spot location ID.

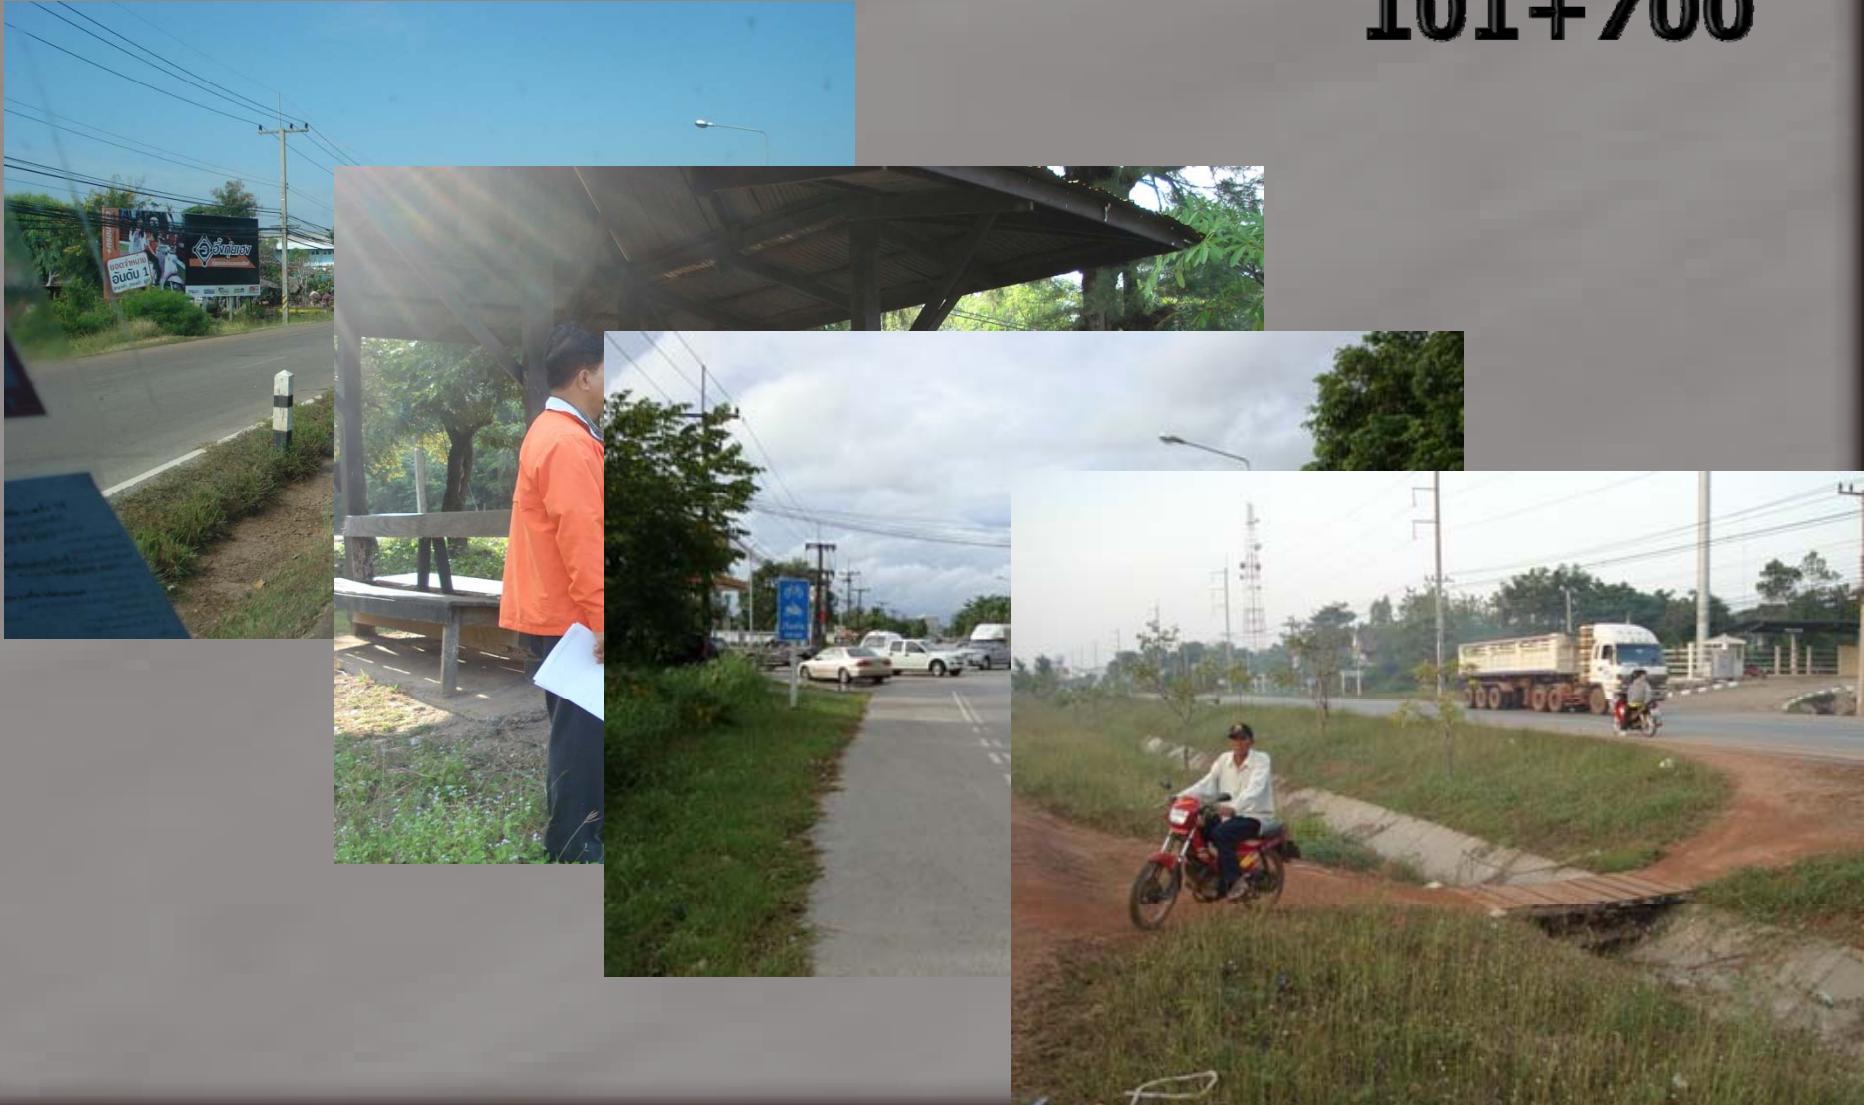
**Route 2  
KM101+200 –  
101+700**

# Launching the black spot improvement program

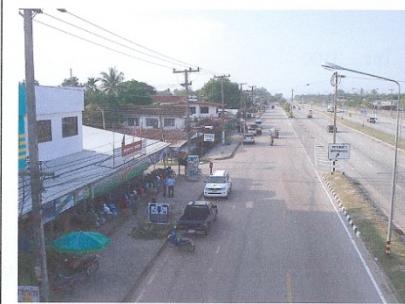
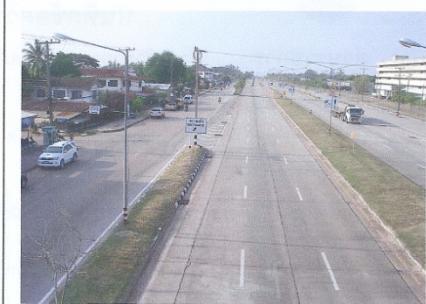
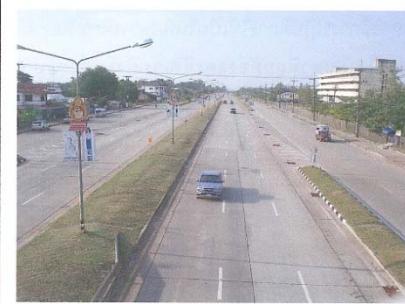
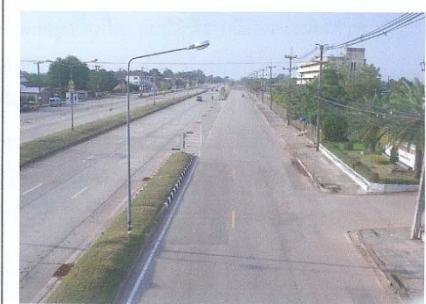
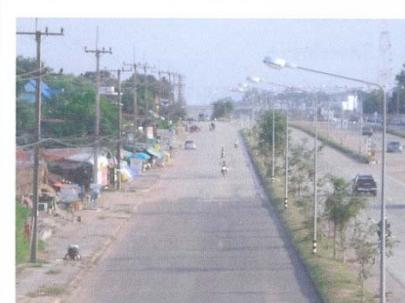
รูปภาพสถานที่จริง

แนวทางการปรับปรุง : ต่อตัวปีบผิวหนัง (Reorient d'angle) (Frontage)

งบประมาณเบื้องต้น..... ๐.๑ ล้าน ..... บาท ลำดับคะแนน(Rating)..... ๓-๓.๕ ..... คะแนน ( ๑ ถึง ๕ )
